## Mechanical Survey of the Conductive Glue Placement Sites on the Production Baseboards

**V 1.0**

August 23, 2002

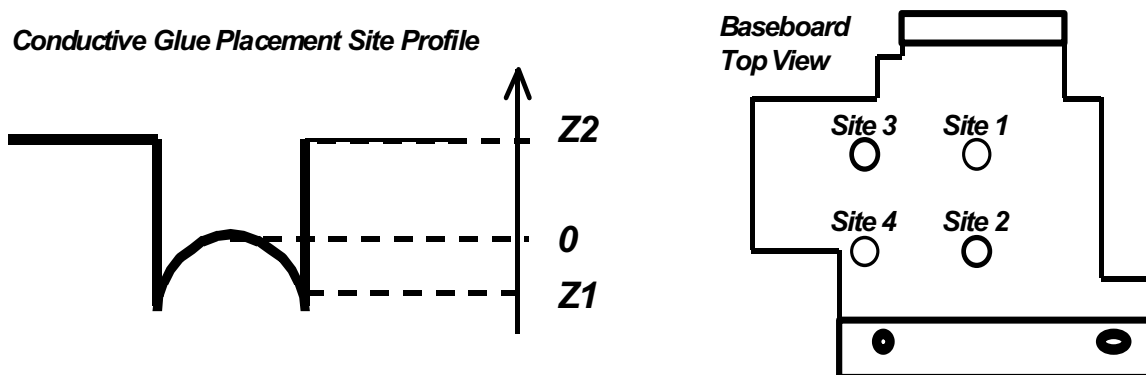
Figure 1 illustrates the definitions. We interpret Z2 as the site depth, and Z1 as the site shape parameter.

Figure 1. Schematic of the conductive glue site measurements.

The Z1 and Z2 are correlated, as shown in Figure 3. For deep sites, the edges of the site are elevated with respect to its center, unlike the schematics in Figure 1.
